Investigation and Simulation of Failure Mechanism of a Port Basin Revetment, Generation of Remediation Design and Re-construction Works

Abstract

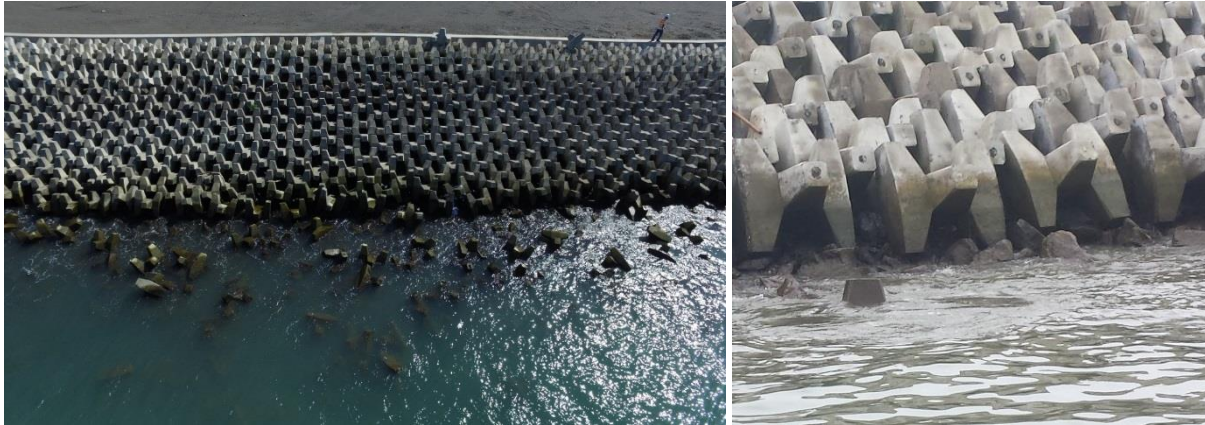
Figure 2: Images of the damage obtained during site inspections

Site inspections were performed by experts both from land and from the water in order to visually inspect the damage of the revetment. It was clear that the concrete units were mainly displaced below the transition between random and regular placed units. It was also visible, just below water level, that several random placed units were not within the original design slope anymore. This can for example clearly be seen in Figure 2.

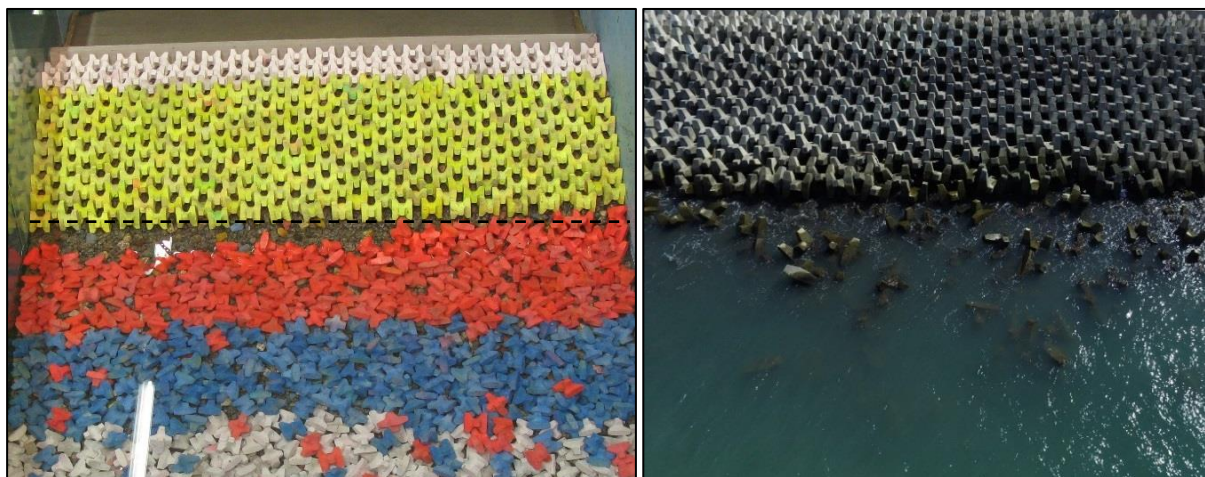
Figure 5: Comparison between simulation of the 'Actual Situation' and the Actual Situation in reality

The 'Actual Situation' test to investigate and verify the expected failure mechanism was then performed using extreme yearly wave heights as occurred in reality. Results of the physical model testing showed similar unit displacements as observed in reality, see Figure 5 for comparison. Units rolled down the slope resulting in a gap around and just below the water level (MSL). It was furthermore clear that non-interlocking units started rocking heavily under high wave conditions and free-lying or extracted units started to roll up and down the slope. This shows that under non-extreme conditions the concrete units are unstable when not interlocked. As soon as a unit is outside of the Armour layer it behaves like a rock. The single-layer 'interlocking' armour layer is not 'self-healing' in this case as downward pressure from upper units is (almost) not present.

It is noted that in reality waves arrive oblique at the structure, which is not included in the 2D model test. Consequently the run-up and run-down is much higher in the model testing, which resulted in significant displacements of the pattern placed units above water level which has not occurred in reality. Therefore these units have been re-placed in their original regular pattern after the 'actual situation' test.
